The six-speed manual transmission for the Turbo Diesel was changed by Dodge from the New Venture 5600 that had been used since 1999 until late in the 2005 model year, to a Mercedes Benz unit, the G56. The G56, as we are now aware, is an aluminum cased six-speed with integral bell housing, and a new (for Dodge) design dual-mass flywheel. The Chrysler noise/vibration/harshness engineering group wanted to "elevate the customer experience" with the change in flywheel design. The G56 shifts easier and smoother, but reaching reverse seems easier with the NV5600 than the G56. Initially, the overdrive was not as steep (0.79 versus 0.73 for the NV5600) in the G56, but there was a change to an overdrive ratio of 0,74 in a new version of the G56 for the 6.7-liter Cummins (2007.5 year model!). The early input shaft has two grooves, which can be seen by removing the front bearing retainer (a stamped steel part that costs \$159) (photo 71-15). The late ratio input shaft has three grooves (photo 71-16). More reports of noise seem to be associated with the later design. A fairly large number of sixth gear failures have occurred, and it may be that the mild 0,79 overdrive ratio causes more drivers

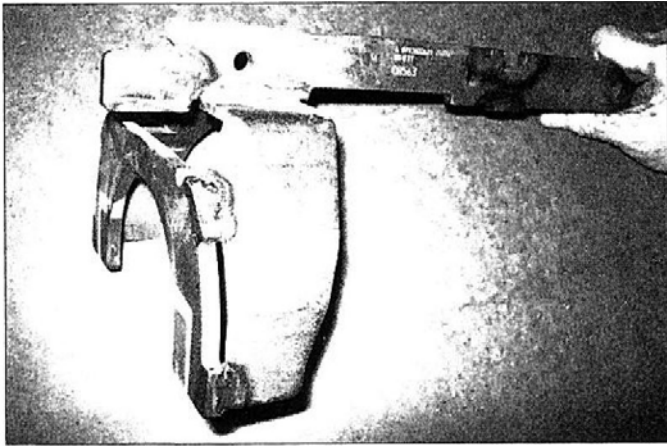
(71-17) Heavy stamped steel shift fork with welds that are prone to failure.

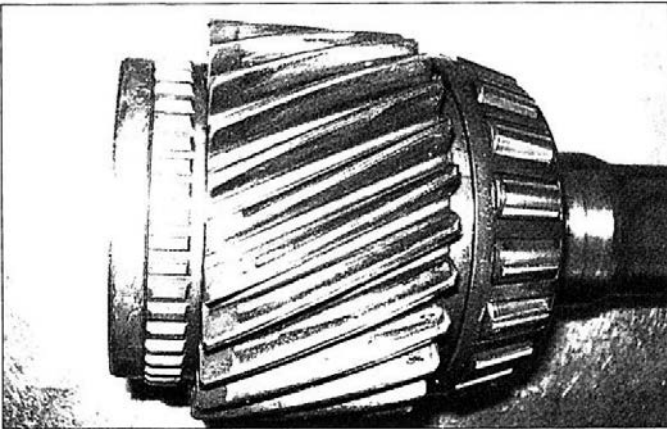
Standard often finds evidence of misalignment of the mainshaft gears versus the cluster gear, shown here on an input gear (photo 71-18). Broken gear teeth can result (photo 71-19). Wear patterns indicate that the teeth are spreading the transmission case, causing wobble in the input gear, and gear teeth are wearing closer to the edges of the teeth. Heavy loads then cause them to break.

(71-18) Input with wear indicating misalignment of gears

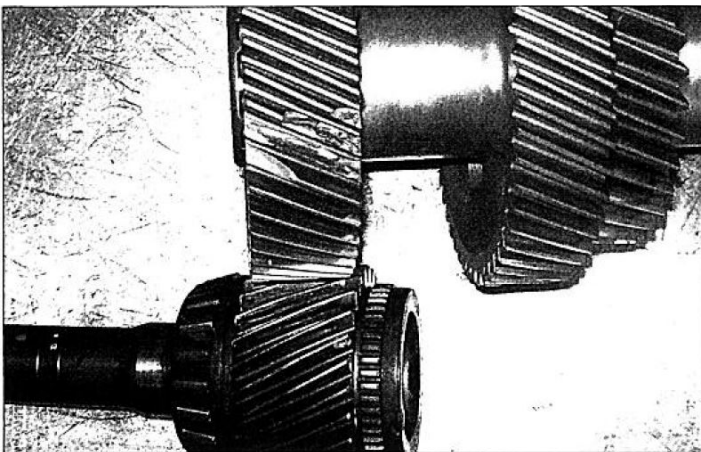
(71-19) Input and cluster with broken teeth caused by poor alignment and heavy loading.

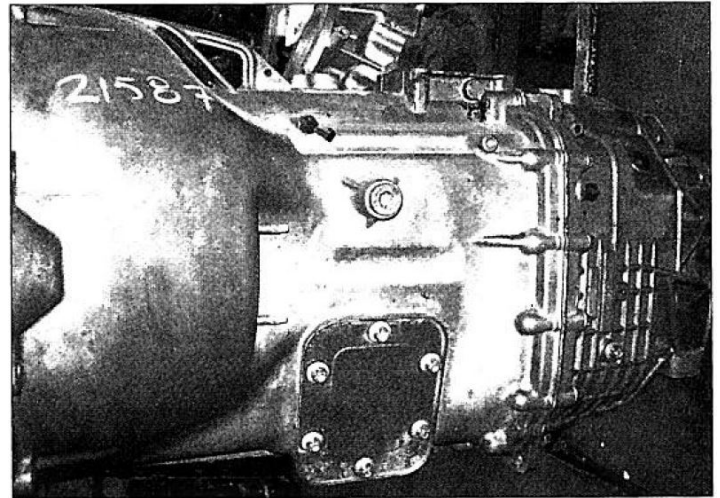
The stock transmission case is two-piece, split crosswise just behind the shifter tower area (photo 71-20). Inside, the front of the case can be seen to include supports for all internal components. The inside view of the rear housing shows corresponding bearing and shaft mounting supports (photo 71-22). Owners have tried to repair cracked cases with poor success. This one was warped to 0.070" out of "square" by welding (photo 71-23).

(71-20) G56 two-piece transmission case.

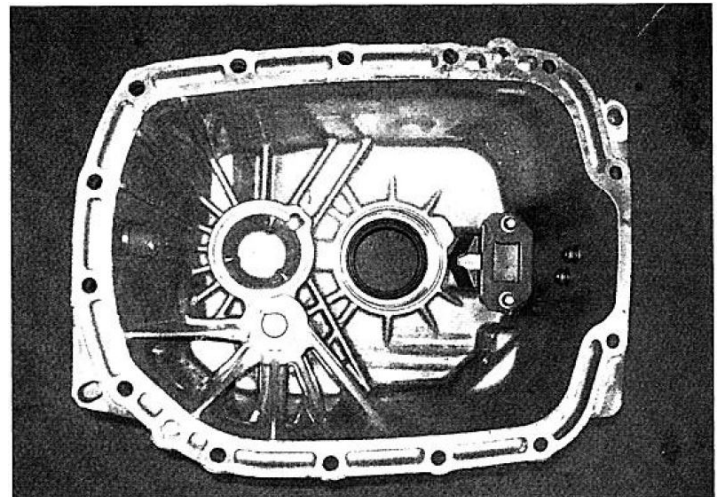
(71-22) Rear half of G56 case viewed from the split at mid-case.

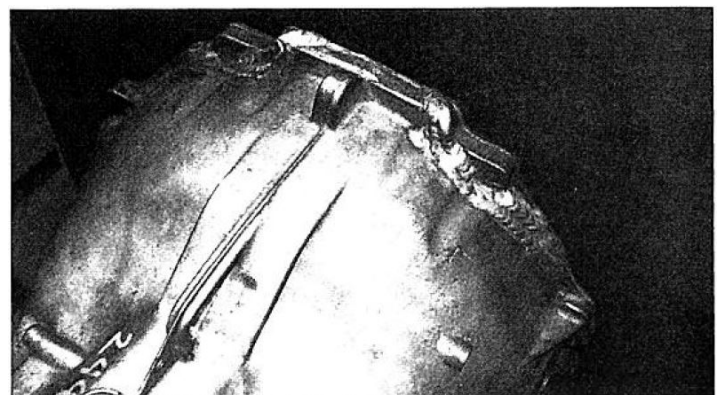
(71-23) Welded but distorted G56 case at bell housing area.

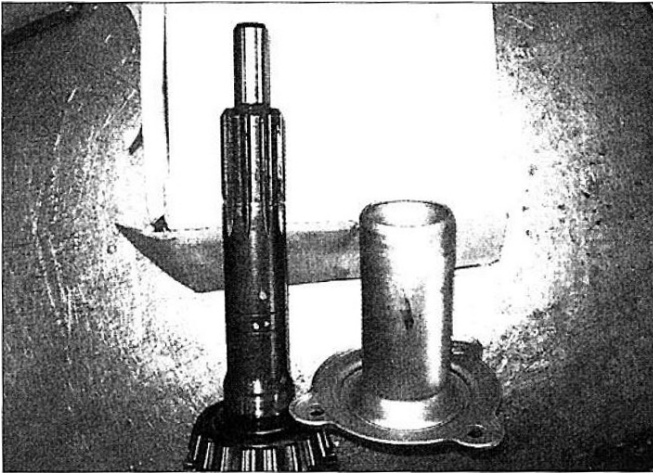
(71-15) Early G56 input gear (0.79 overdrive ratio) and front bearing retainer.

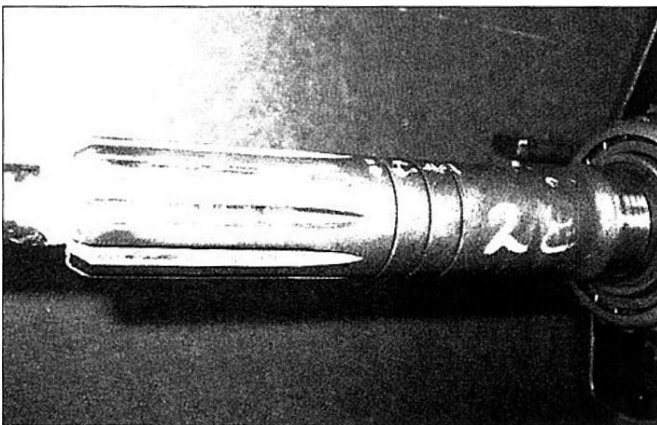
(71-16) Late G56 input (0.74 overdrive).

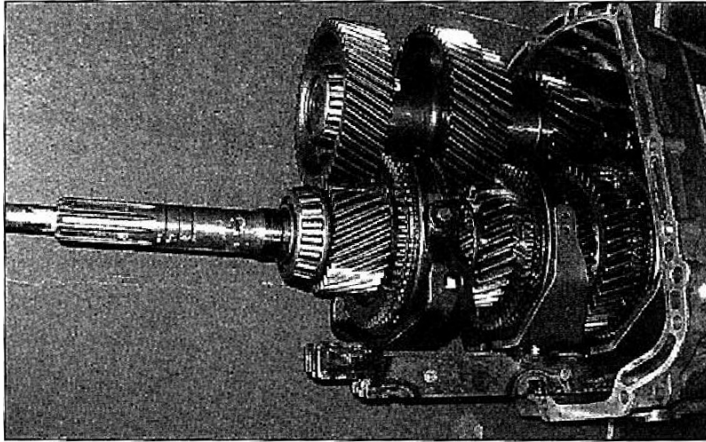
(71-24) Rear half of the case with mainshaft and cluster assemblies.

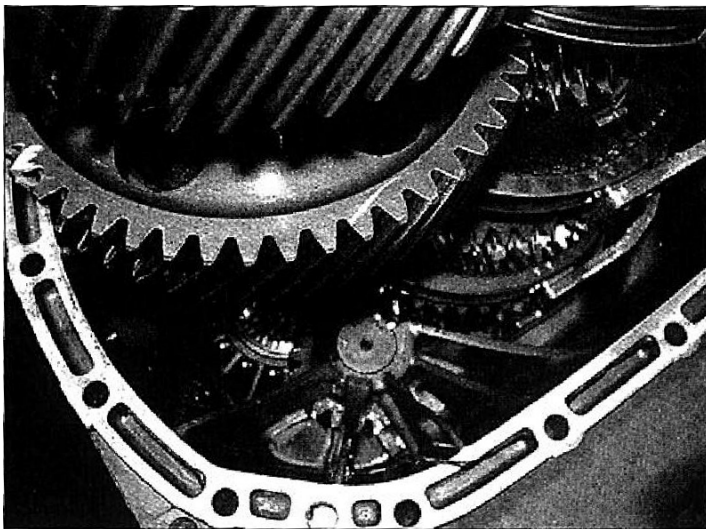
(71-25) Close up view of reverse idler gear in rear half of case.

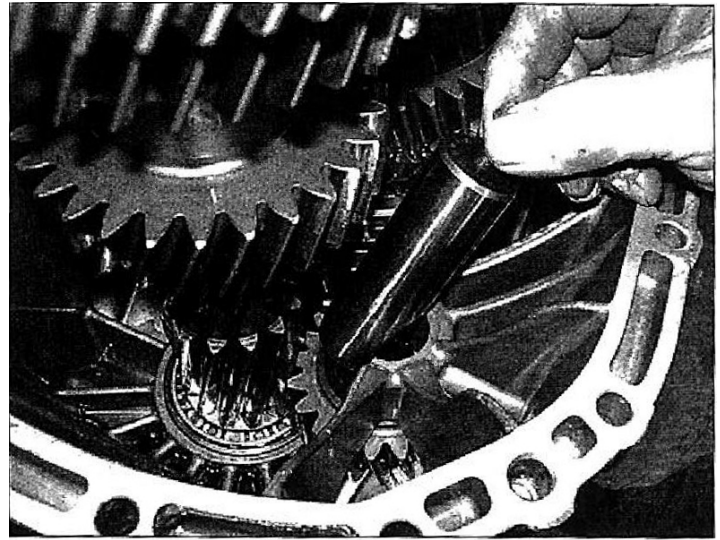
(71-26) Removal of idler gear shaft.

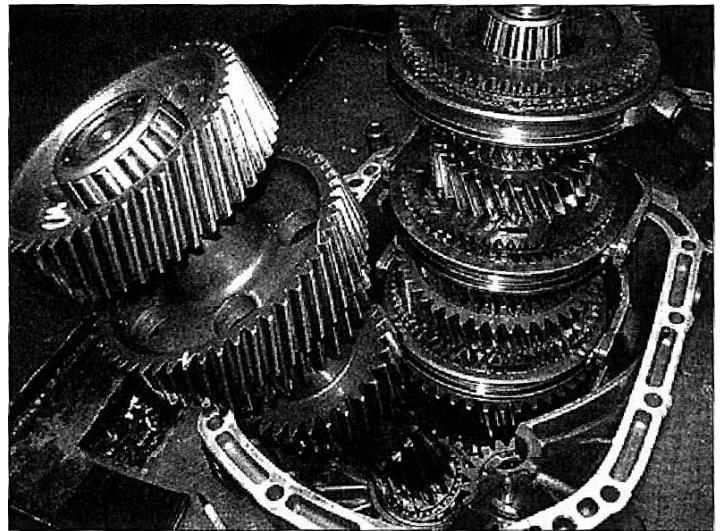
(71-27) Separation of cluster and mainshaft assemblies after moving reverse idler gear out of the way.

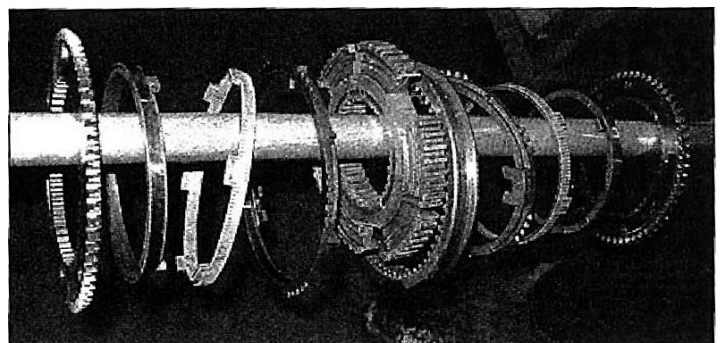
(71-28) Synchronizer assembly for one pair of gears (1.2, etc.)

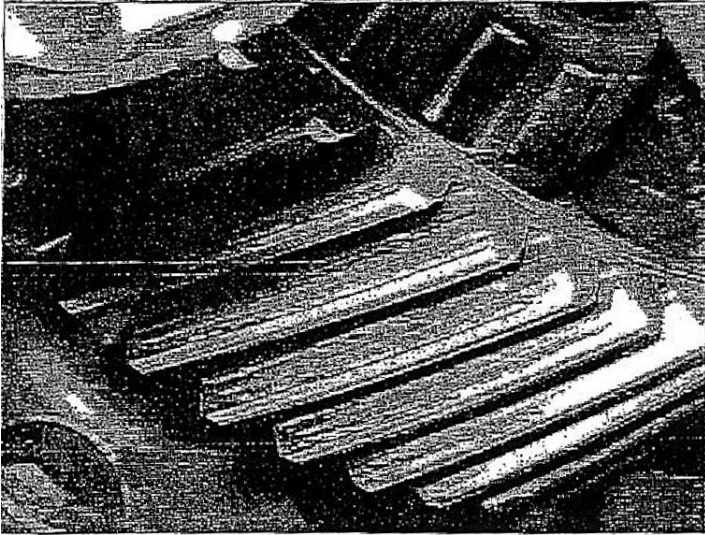
Standard has seen electrolytic pitting of gear teeth (photo 71-29) similar to that seen in automatic transmissions which also have aluminum cases. An extra ground strap as is sometimes added to automatics may be the cure for this issue. That damage is seen on the leading drive side and edge of cluster and main gear teeth, presumably from an electric field being generated.

(71-29) Electrolytic pitting of gear teeth
